**INFLUENCE OF SMALL VESSEL OPERATION AND
PROPULSION SYSTEM ON LOGGERHEAD SEA TURTLE
INJURIES**

In Partial Fulfillment
of the Requirements for the Degree
Master of Science in the
School of Civil and Environmental Engineering

Georgia Institute of Technology
May 2010

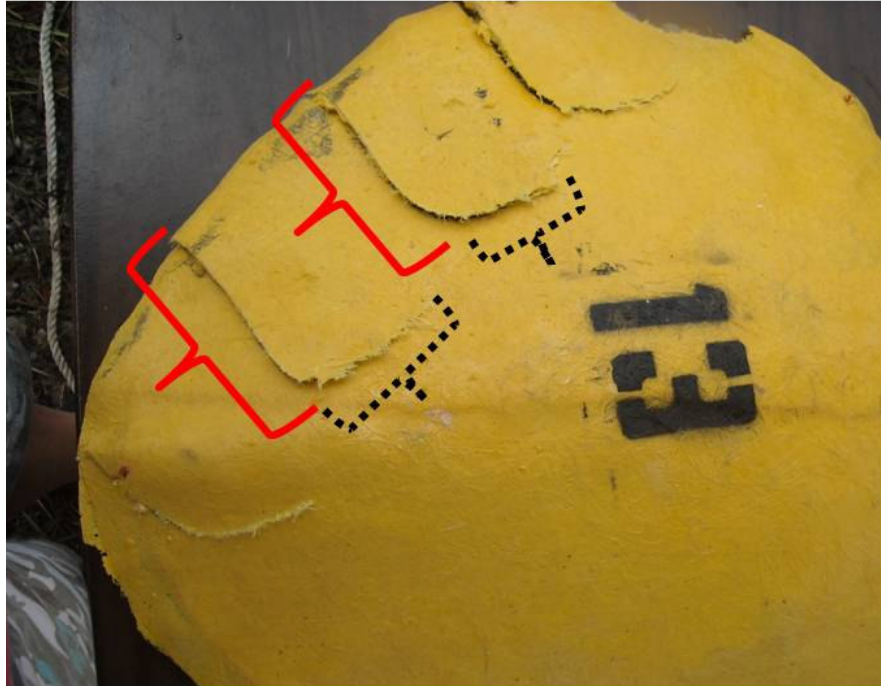
The wounds on each model carapace were categorized using the above criteria. When damage to the carapace was observed, it was typically parallel slicing wounds from the propeller, blunt force wounds from the skeg or another piece of the outboard motor foot where a section of the carapace was torn away, or a combination of the two. Propeller wounds were measured as a straight distance end to end (not following the sigmoid curve of the cut). These lengths were then summed to get a total cut length for each carapace. The composite material used in the synthetic carapaces has a tendency to tear at 90 degree angles from the ends of propeller cuts; these areas were not included in the quantification of the wound severity. Figure 5.1 shows a typical carapace with propeller cuts, showing the cut from the propeller and the tearing of the composite material.

Figure 5.1. Example of propeller cut wound observed during tests. The solid brackets represent cut length measured. The dashed brackets show the area of tearing of composite material not included in the cut length calculations.

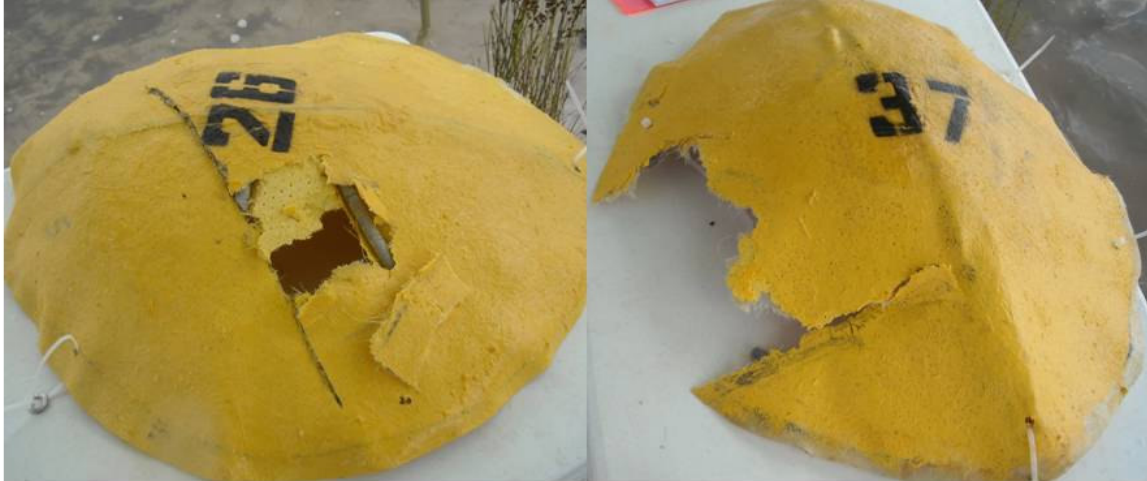
Section loss wounds from blunt force impact were measured and the area lost was approximated by fitting the measurements to basic geometric shapes. Figure 5.2 shows examples of blunt force wounds observed. Columns 4 and 5 in Table 5.1 show the length of propeller cuts and/or the percentage of total area a section loss represents; column 6 indicates whether the wounds observed were characterized as catastrophic. A complete table of all tests along with comments collected on the data sheets can be found in Appendix C. Photographs from all of the field experiments appear in Appendix D. Below, the results of each type of test are described, along with a discussion of accelerometer data.

Figure 5.2. Examples of blunt force wounds observed in test samples.

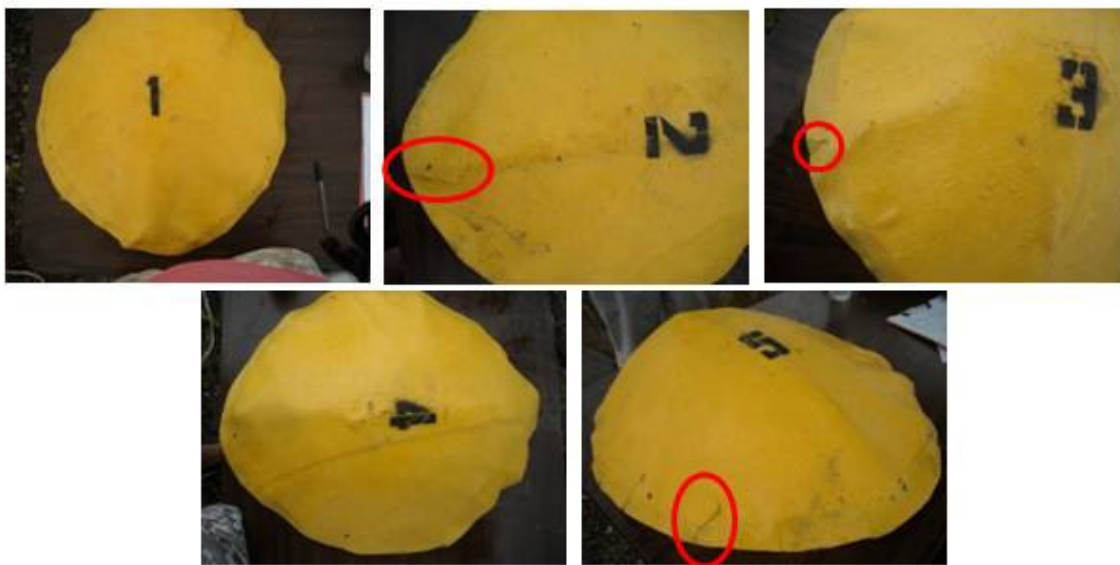
Carapace Number	Boat Speed (km/h)	Initial Boat Orientation	Total Length of Cuts (cm)	Percent of Total Area Damaged	Catastrophic
1	6.5	2-1	NA	NA	
2	7.0	4	11	NA	X
3	6.5	3-4	5	NA	X
4	6.6	3	NA	NA	
5	7.0	3-4	12	NA	X

Figure 5.3. Model carapaces after tests with **standard motor configuration**, no propeller guard, **idle speed**, with the test specimen at the **surface**. Damage to the carapace is circled in red.

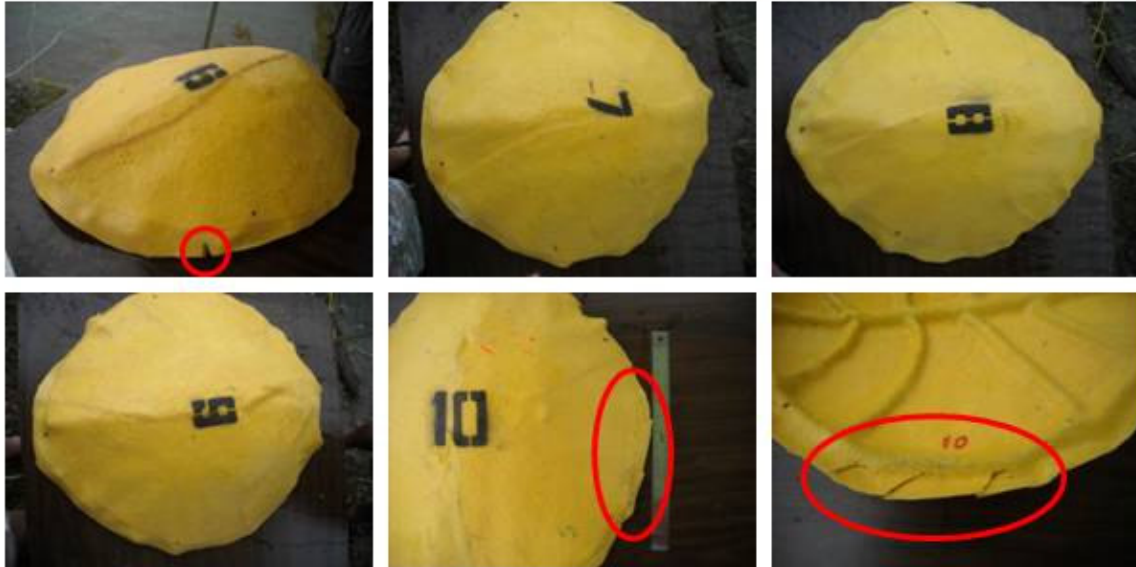
Carapace Number	Speed (km/h)	Initial Boat Orientation	Total Length of Cuts (cm)	Percent of Total Area Damaged	Catastrophic
6	6.5	2	2	NA	
7	6.2	4	NA	NA	
7	6.3	3	NA	NA	
8	6.4	4-1	NA	NA	
9	7.2	3-4	NA	NA	
10	6.6	1-2	15	NA	X

Figure 5.4. Results from tests with **standard motor configuration, idle speed, and model at propeller depth.**

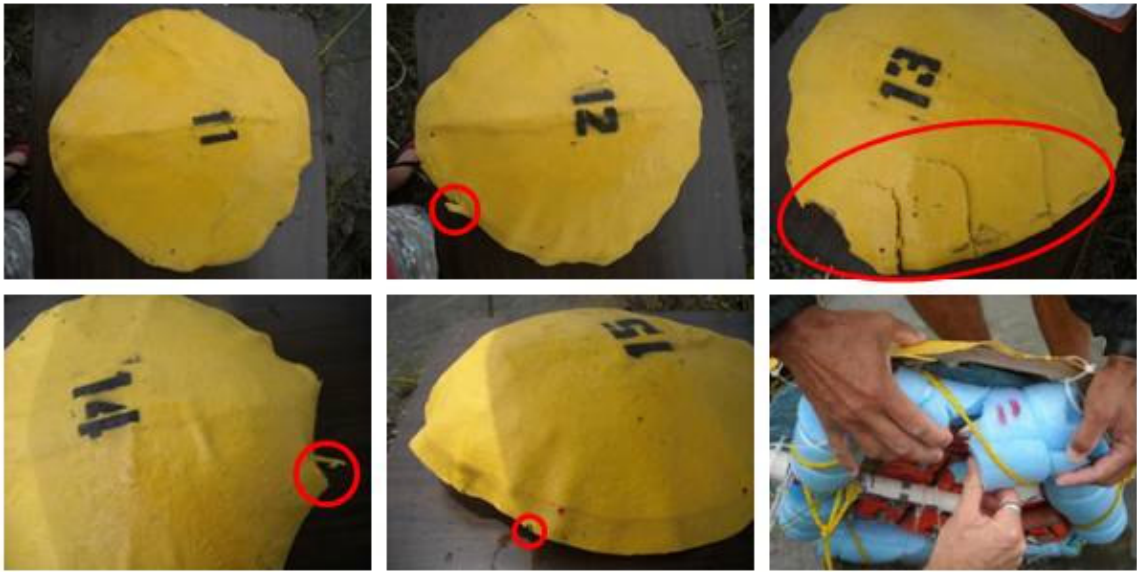
Carapace Number	Speed (km/h)	Initial Boat Orientation	Total Length of Cuts (cm)	Percent of Total Area Damaged	Catastrophic
11	15.5	3-4	NA	NA	
12	17.9	1-4	8	NA	X
13	14.9	4	53	1%	X
14	14.0	3	10	NA	X
15	15.2	3	3	NA

Figure 5.5. Tests with **standard motor configuration, sub-planing speed**, and model animal at **propeller depth**. Lower right shows damage to the frame during test number 12.

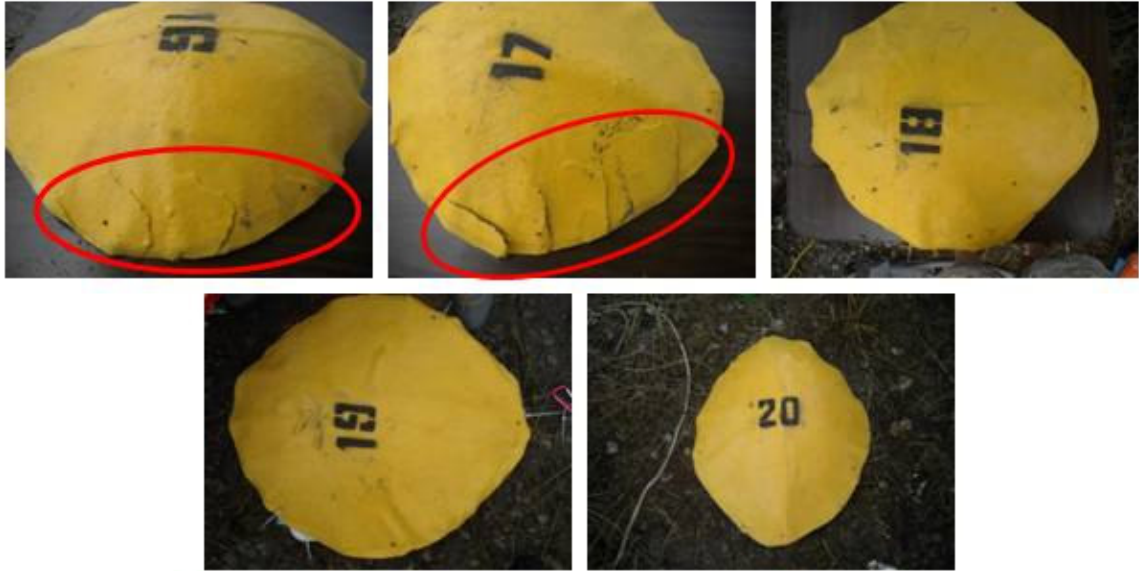
Carapace Number	Speed (km/h)	Initial Boat Orientation	Total Length of Cuts (cm)	Percent of Total Area Damaged	Catastrophic
16	15.4	2	27	NA	X
17	14.3	4	50	NA	X
18	13.9	1-4	NA	NA	
19	15.4	2-3	NA	NA	
19	NA	NA	NA	NA	
20	16.3	2-3	NA	NA	
20	16.2	1-2	NA	NA	
20	15.9	1	NA	NA	
20	15.4	1	NA	NA	
20	15.5	2	NA	NA	
20	14.0	4	NA	NA

Figure 5.6. Tests with **standard motor configuration, sub-planing speed** and model animal at the **surface**.

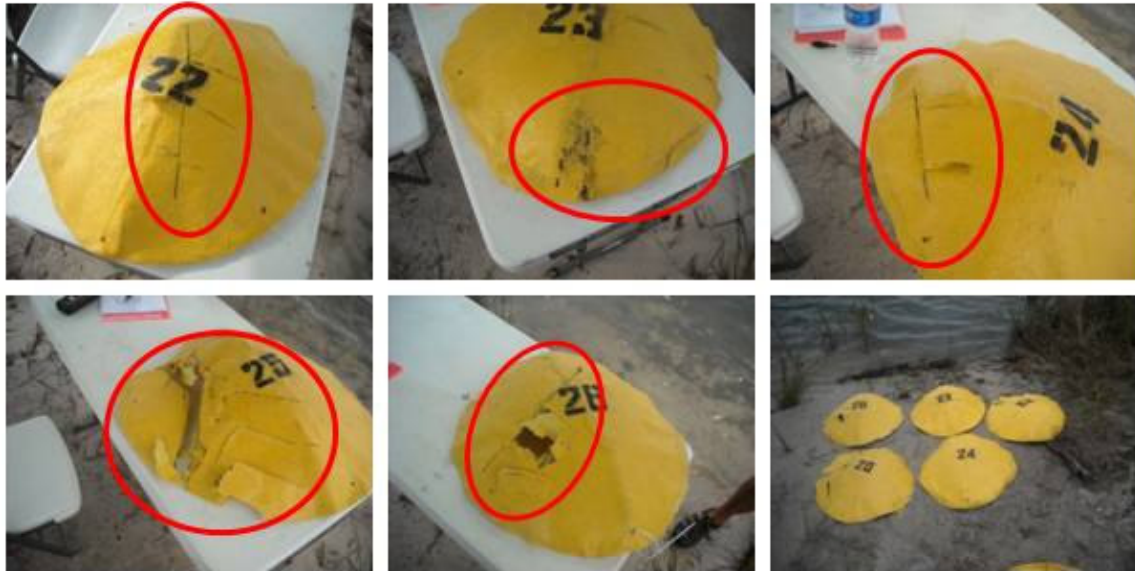
Carapace Number	Speed (km/h)	Initial Boat Orientation	Total Length of Cuts (cm)	Percent of Total Area Damaged	Catastrophic
22	44.2	2-3	80	<1%	X
23	40.1	3	12	6%	X
24	41.5	3-4	40	NA	X
25	42.7	3-4	101	8%	X
26	42.0	3-4	36	2%	X

Figure 5.7. Results from tests with **standard motor configuration, planing speed** and model animal at **propeller depth**.

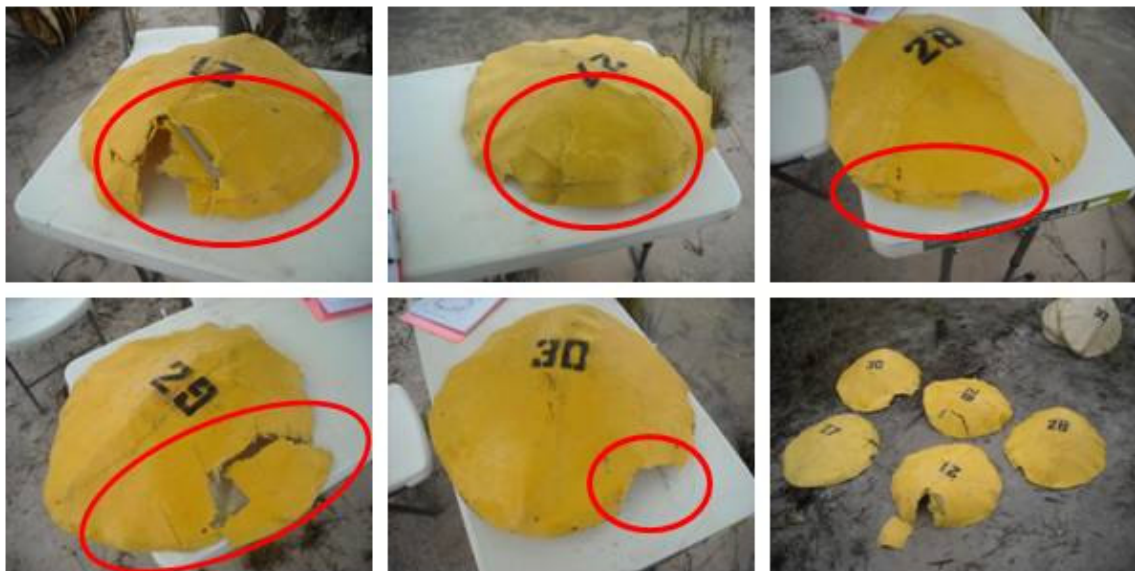
Carapace Number	Speed (km/h)	Initial Boat Orientation	Total Length of Cuts (cm)	Percent of Total Area Damaged	Catastrophic
21	41.7	1	NA	33%	X
27	40.1	1-2	NA	6%	X
28	41.6	1-4	NA	4%	X
29	42.7	1	41	6%	X
30	41.6	3	NA	4%	X

Figure 5.8. Results from tests with **standard motor configuration, planing speed** and model animal at the **surface**.

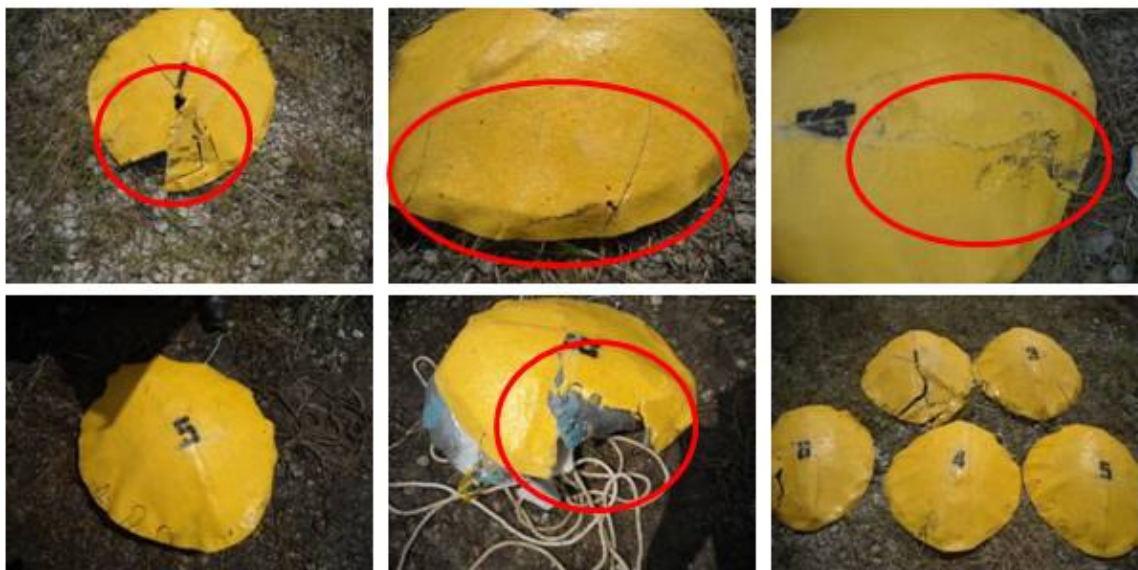
Carapace Number	Speed (km/h)	Initial Boat Orientation	Total Length of Cuts (cm)	Percent of Total Area Damaged	Catastrophic
1	40	3	10	15%	X
3	43.2	1-2	NA	4%	X
4	38.5	3	27	5%	X
5	39.2	2	NA	NA	
6	42.5	4	NA	15%	X

Figure 5.9. Results from “floater” trials at **planing** speed.

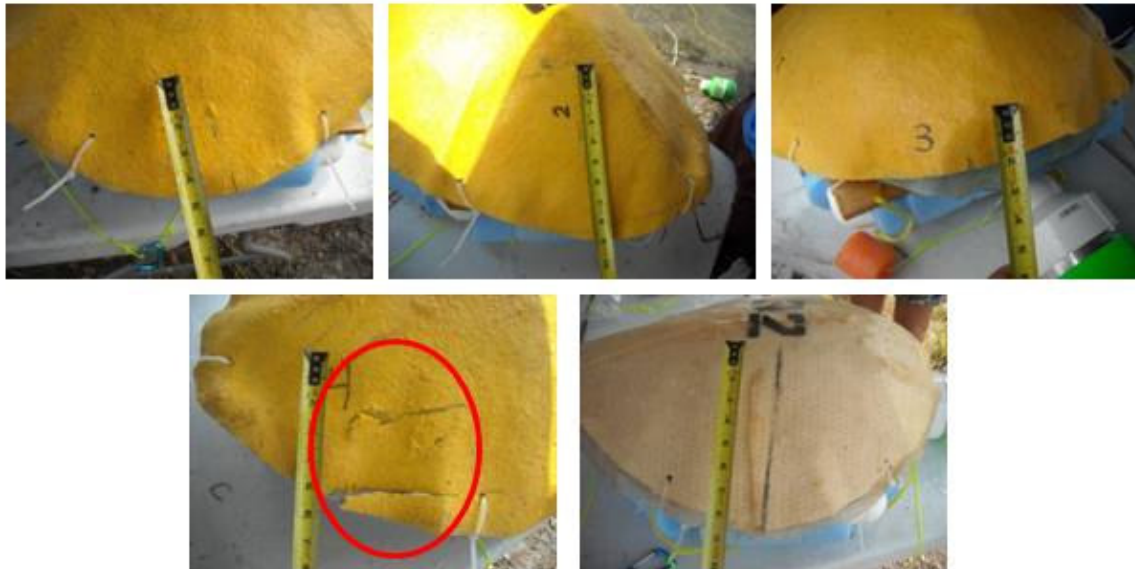
Carapace Number	Speed (km/h)	Initial Boat Orientation	Total Length of Cuts (cm)	Percent of Total Area Damaged	Catastrophic
31	6.5	2	NA	NA	
31	6.3	3	NA	NA	
31	6.3	1	NA	NA	
31	6.4	2	20	NA	X
32	7.0	2	NA	NA

Figure 5.10. Results from tests with the **Hydroshield®**, at **idle speed**, with model animal at **propeller depth**.

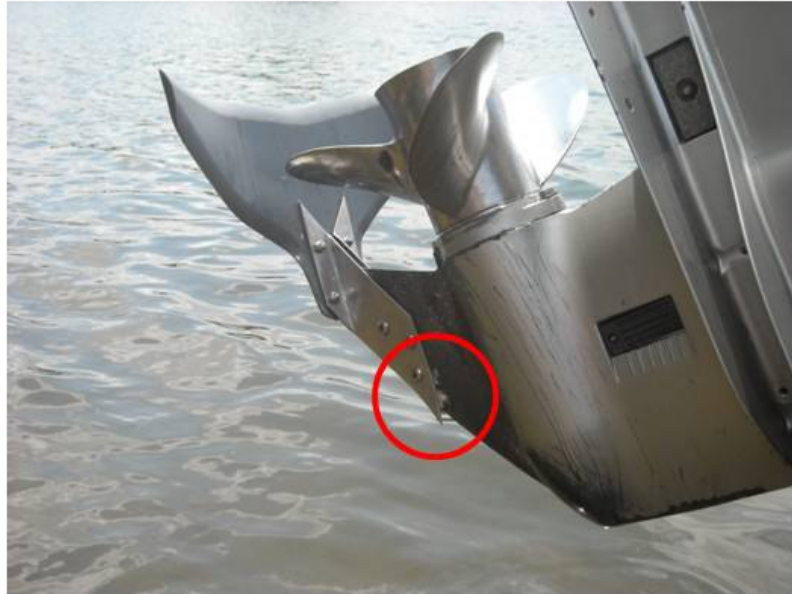
All five tests performed with the Hydroshield® on the motor, at planing speed and with the model animal at propeller depth, resulted in catastrophic carapace damage. Three carapaces had large puncture wounds from blunt force contact. The other two showed large areas of parallel propeller wounds penetrating the carapace. Results are comparable to tests run at with the standard outboard configuration as far as the likelihood of fatality. However, these tests displayed more blunt force wounds than observed with the standard configuration. There was a small, sharp piece of the Hydroshield® that protruded from the front of the skeg (Figure 5.10) that appeared to cause some of the damage. Table 5.9 and Figure 5.12 show the results.

Figure 5.11. Hydroshield® installed on outboard motor. Circle highlights the edge protruding from front of motor skeg.

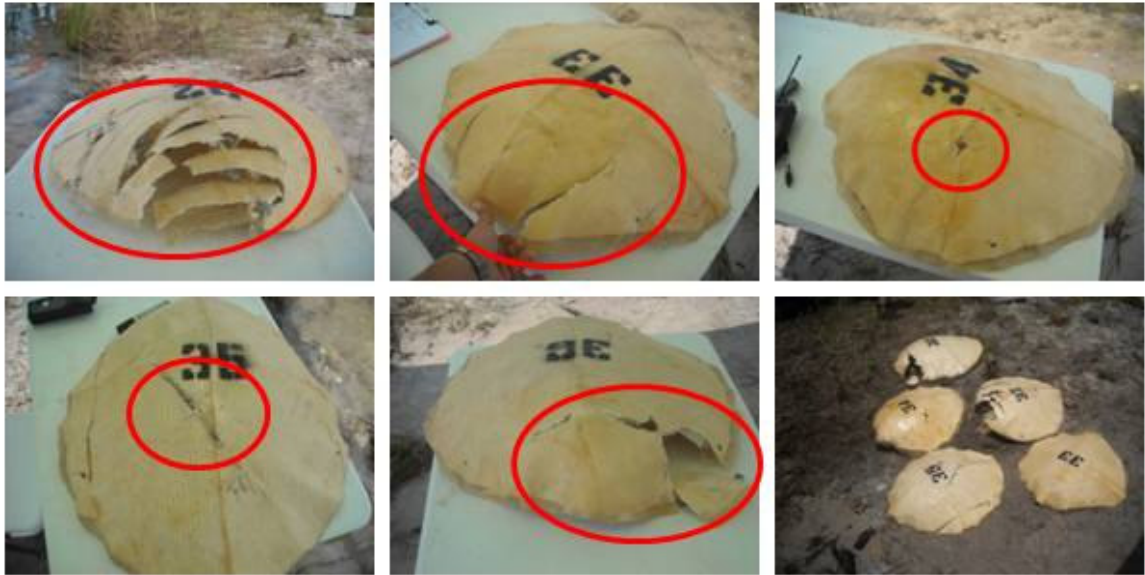
Carapace Number	Speed (km/h)	Initial Boat Orientation	Total Length of Cuts (cm)	Percent of Total Area Damaged	Catastrophic
32	41.2	1	150	10%	X
33	40.7	3-4	74	NA	X
34	40.7	1-4	NA	<1%	X
35	39.8	2-3	NA	<1%	X
36	38.7	1-4	NA	28%	X

Figure 5.12. Results from the tests with the **Hydroshield®**, at **planing speed** and model animal at **propeller depth**.

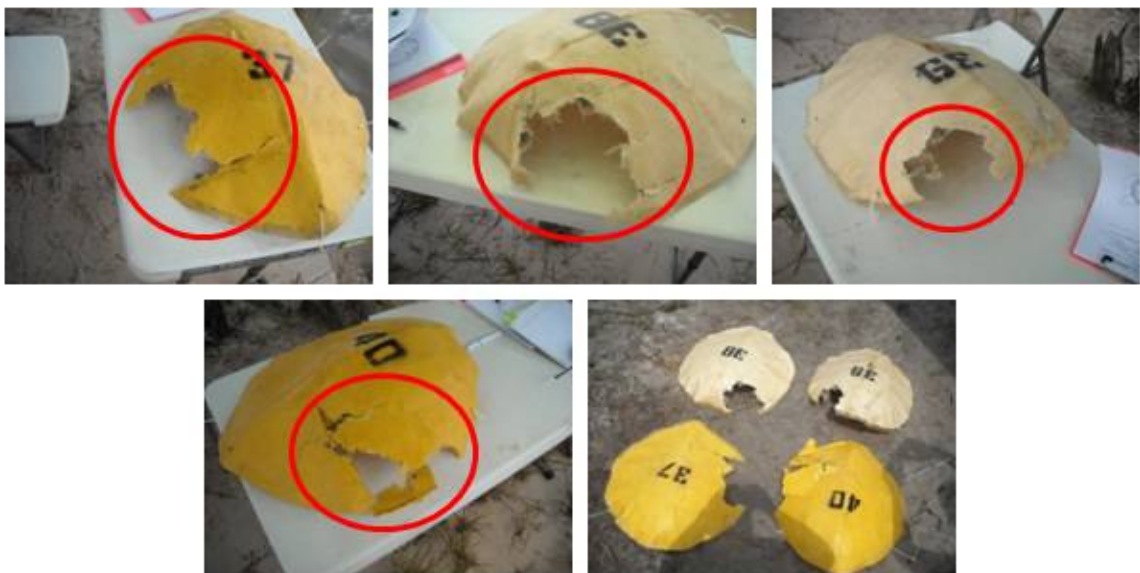
Carapace Number	Speed (km/h)	Initial Boat Orientation	Total Length of Cuts (cm)	Percent of Total Area Damaged	Catastrophic
37	39.7	4	NA	11%	X
38	41	1	NA	9%	X
39	42	1-2	NA	11%	X
40	40	1	NA	5%	X

Figure 5.13. Results from tests with the **Prop Buddy®**, at **planing speed**, with model animal at **propeller depth**.

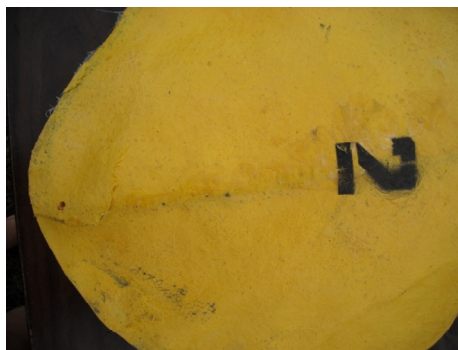
Small prop marks at position 2-3.

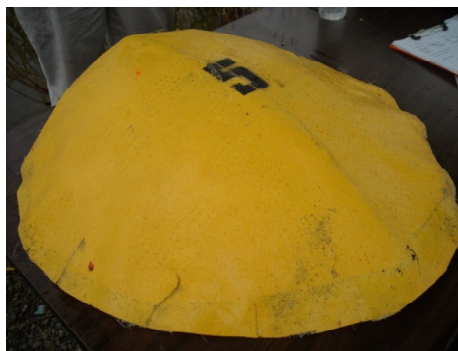
Prop cuts in the 3-4 position.

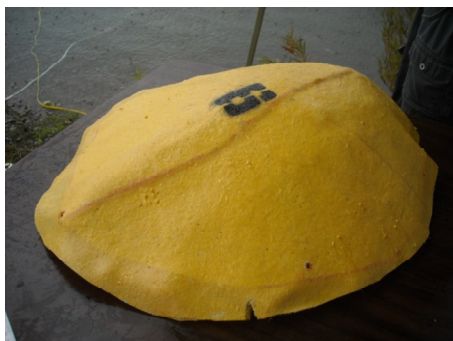
Small notch in the 3-4 position.

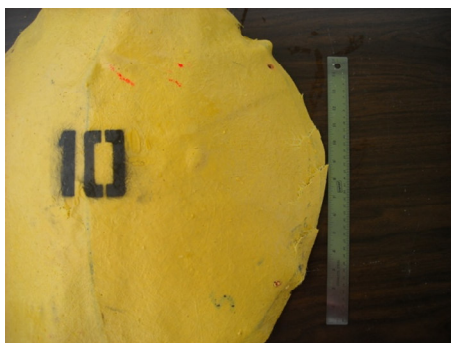
Prop cuts at position 2.

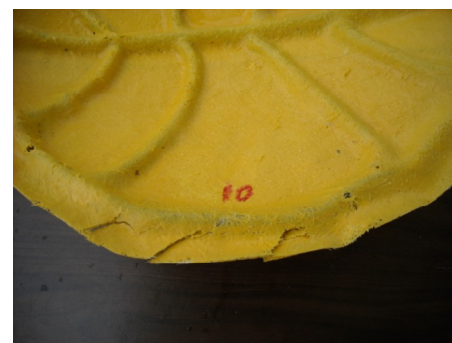
Underside of cuts on shell number 10.

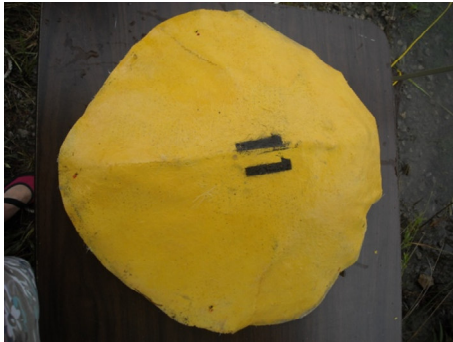
No visible damage to shell. Frame smashed, cut at position 1-2.

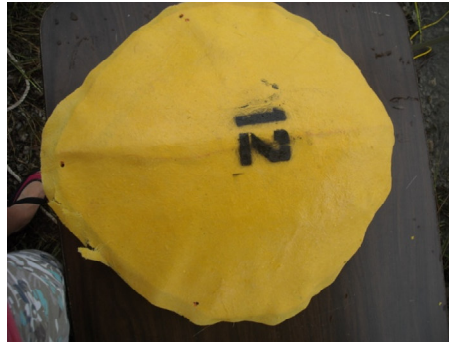
Small prop cuts on shell in 2-3 position. Slices through frame at position 2-3.

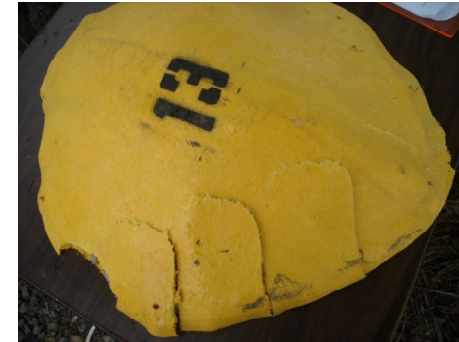
Large prop cuts at position 3-4. Piece of shell missing at position 4.

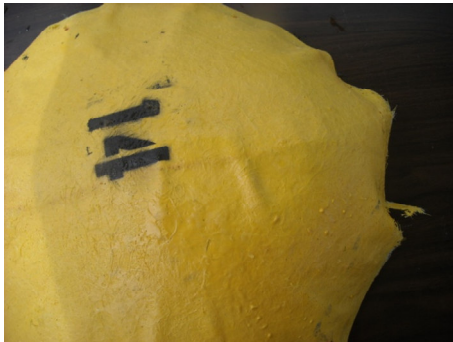
Small cut at position 1-2.

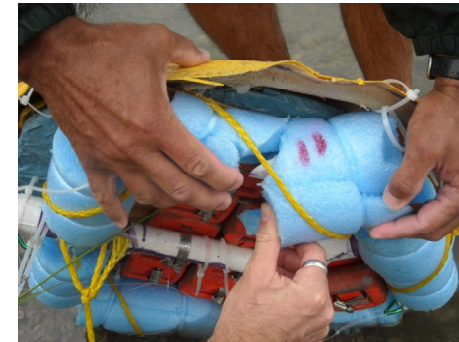
Damage to the frame from test on shell number 11.

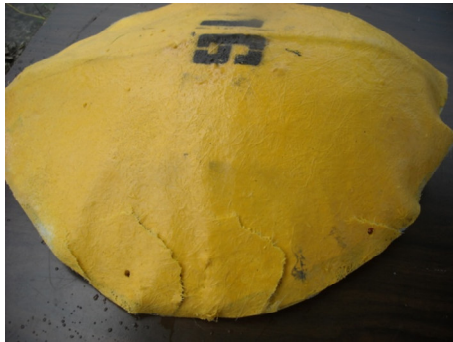
Prop cuts along the edge at position 2.

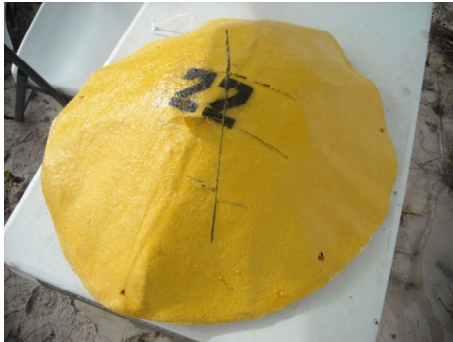
Skeg mark and prop cuts across the top of the shell from position 2-3 to 1-4.

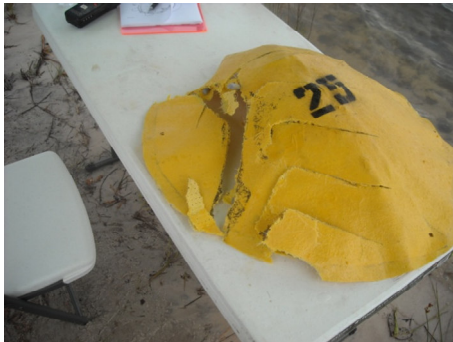
Prop cuts and major damage along left side from position 3 to position 1.

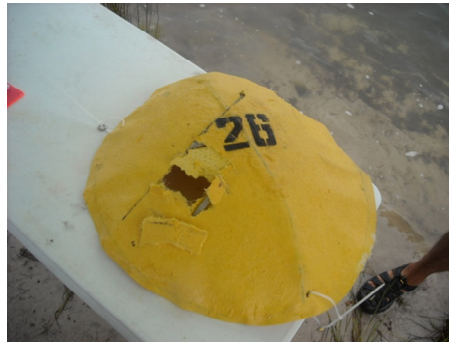
Skeg mark and prop cuts across top of shell from position 4 to position 1-2.

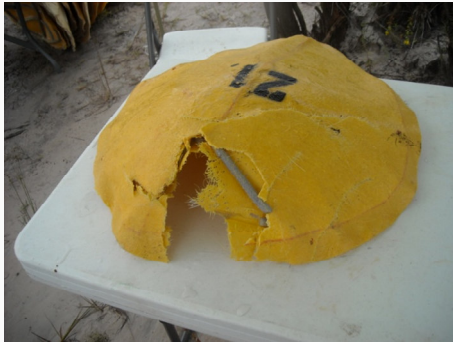
Blunt force and/or prop wound at position 1-4.

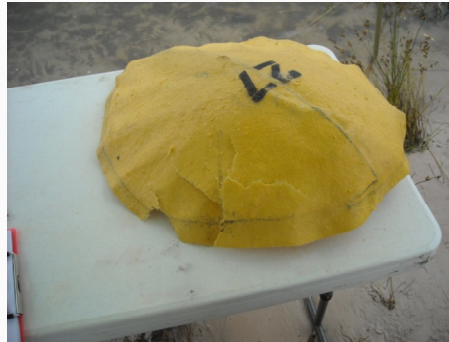
Blunt force at position 1-2. Severe frame damage.

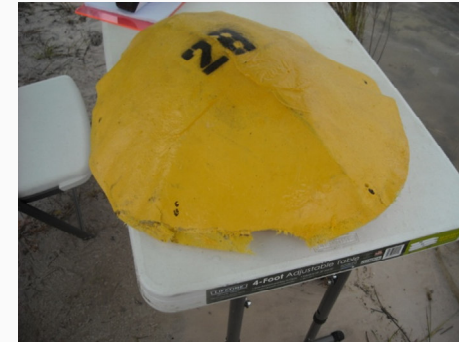
Ragged cut along the edge at position 3-4.

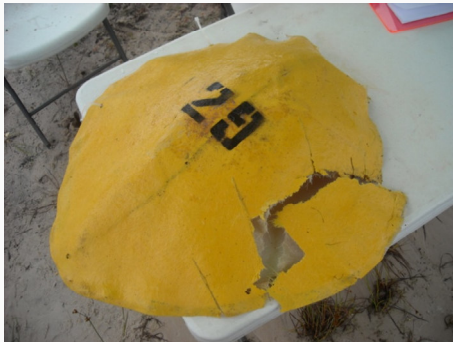
Blunt force and/or prop wound at position 2. Severe frame damage.

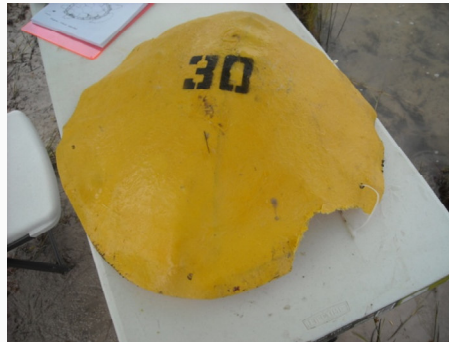
Blunt force at position 2-3. Major frame damage.

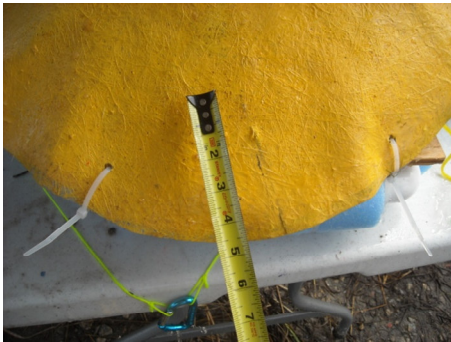
Mark with very slight tear at position 2.

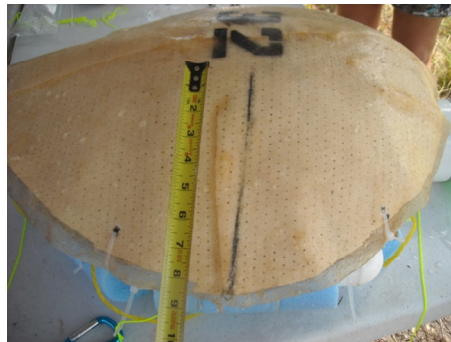
Mark with very minor damage on edge at position 2.

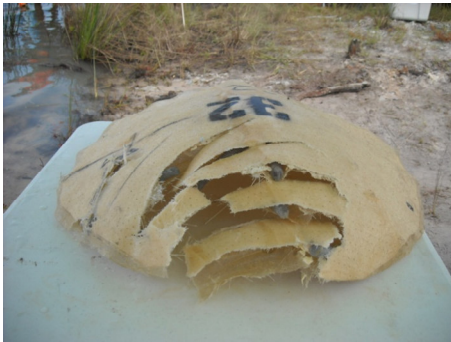
Blunt wound with prop cuts at position 1-2. Major frame damage.

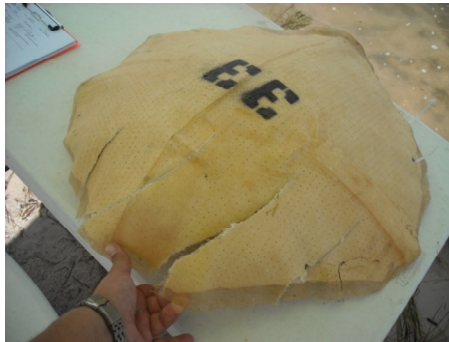
Prop cuts along top of shell from position 1-4 to 1-2.

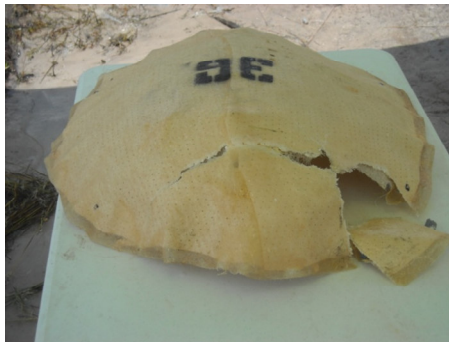
Blunt/ skeg tear off damage at position 1-4.

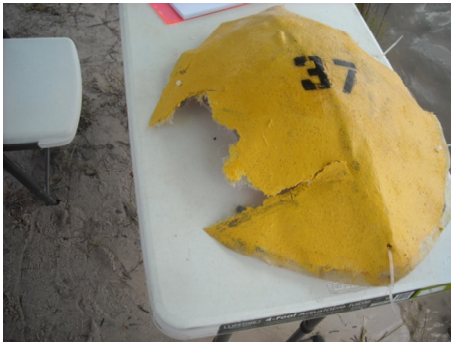
Blunt strike, large tear out at position 4.

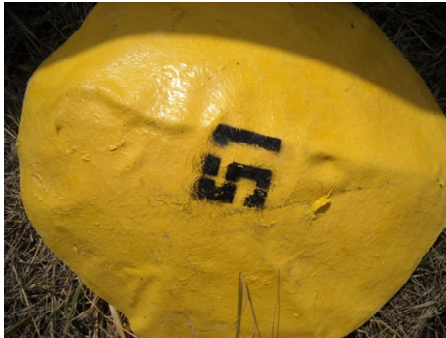
Small cut, not through. 2 lines from intake grating on top.

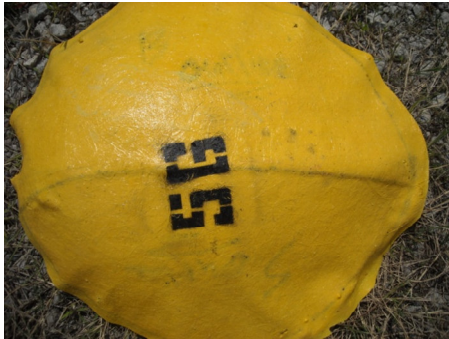
Light scraping on top of the shell.

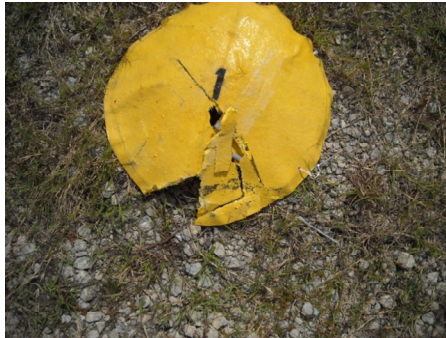
Severe damage. Skeg and prop cuts at position 3.

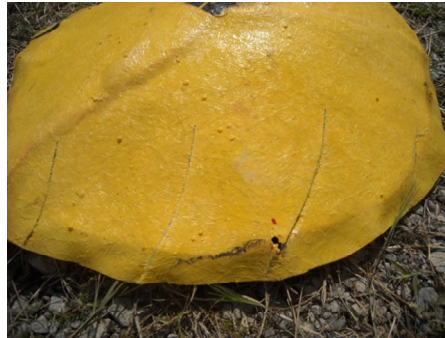
4 prop cuts penetrate shell at position 2.

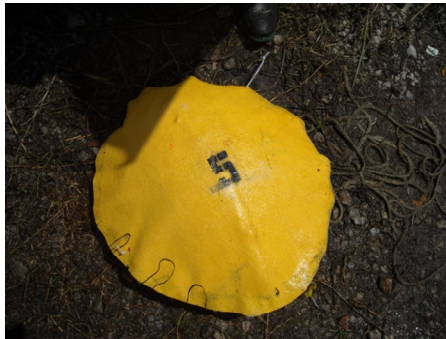
No visible shell damage. Major frame damage.

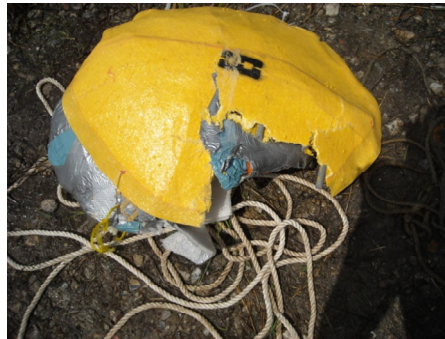
Major frame and shell damage. Blunt impact at position 3-4.
